Analysis of aging status of silicone rubber insulation material and research progress of its repair Countermeasures

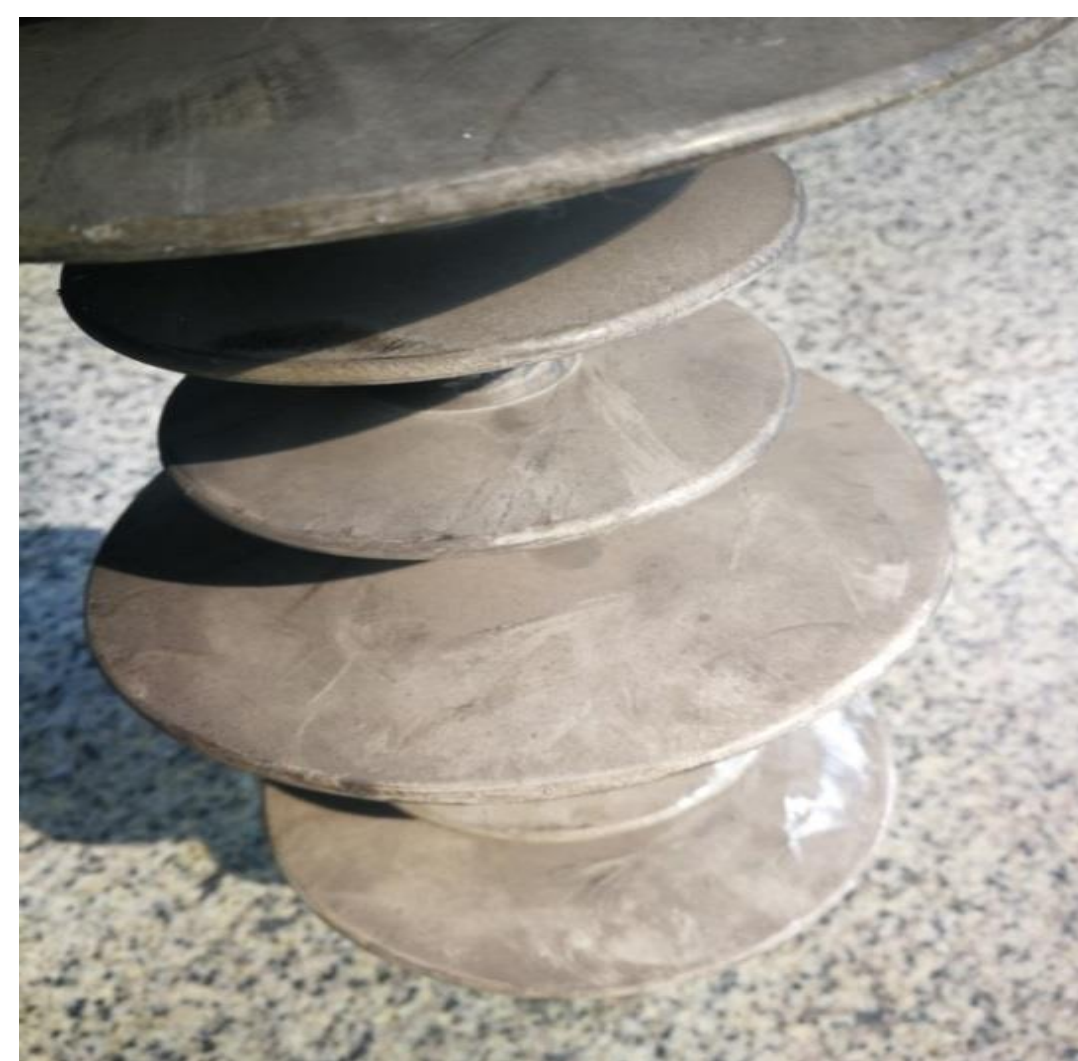
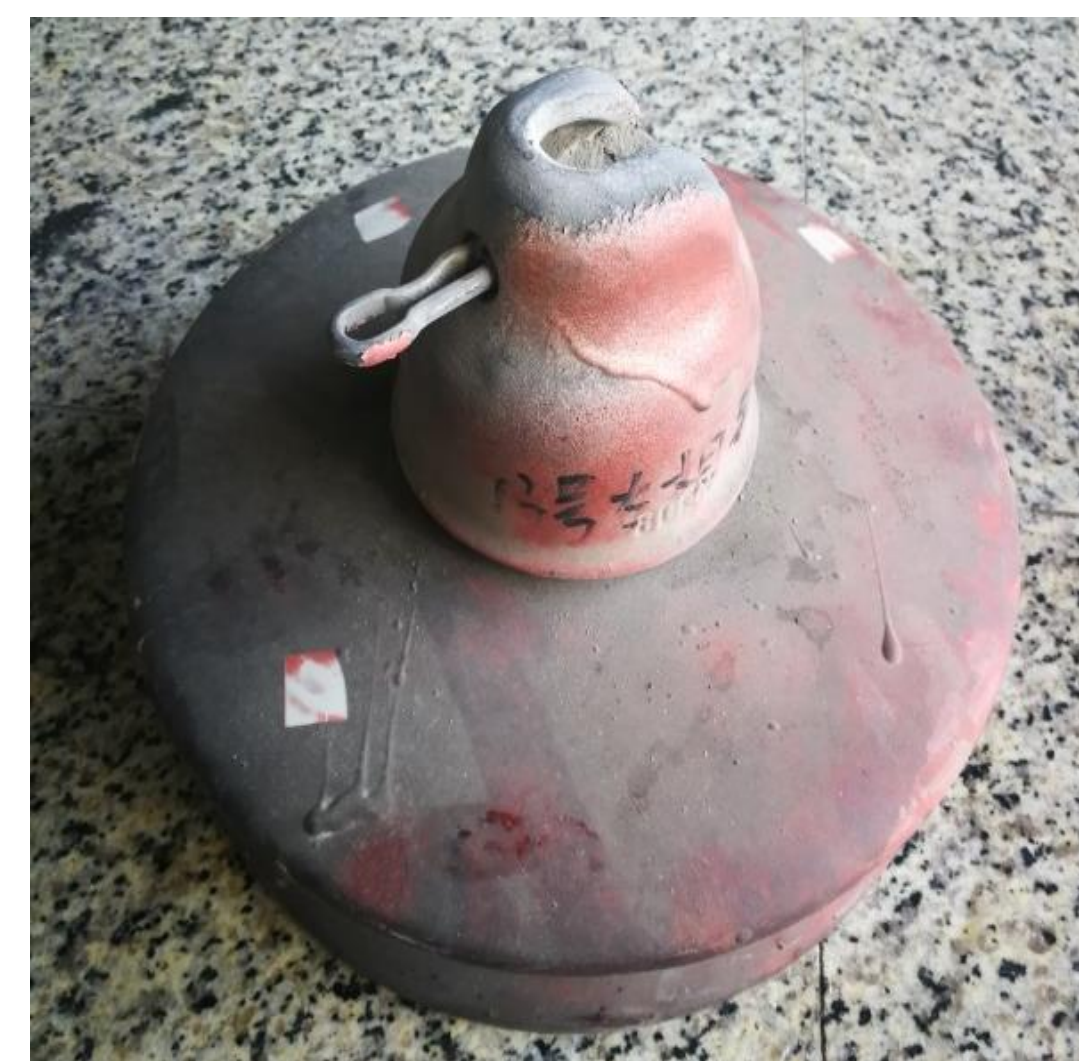
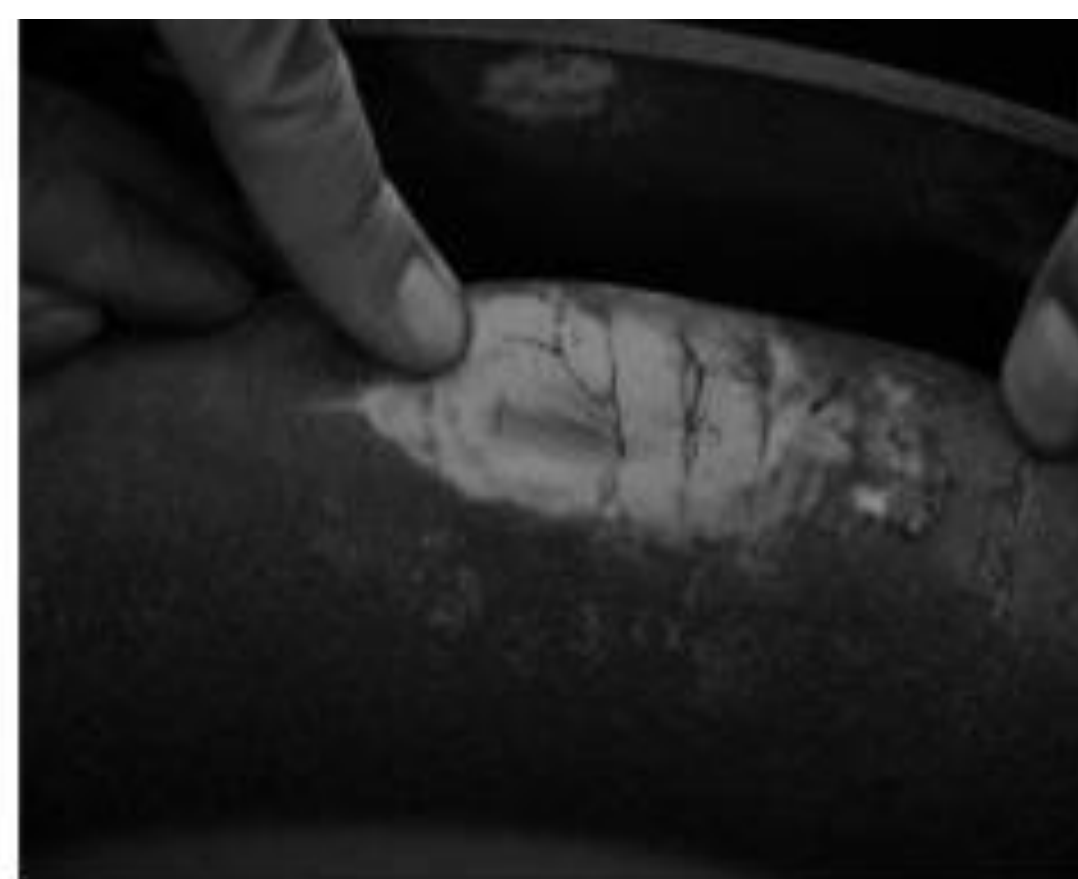
Figure 1. Surface modification of silicone rubber insulator before and after aging
(a. Before aging; b. After aging)

The micro morphology of the surface of the silicone rubber insulator can be observed by SEM, and the magnification of the sample can be between 500 times and 5000 times, as shown in **Figure 1(a)**. It can be seen from **Figure 1(a)** that the surface of the new silicone rubber insulator is relatively flat without obvious holes, cracks and particles; With the increase of the operation time of insulator, as shown in **Figure 1(b)**, it gradually aging, rough surface, more holes and particles, even cracks.
